Leakage & Inappropriate Use Report

Sample Report

Bob's Pet Food

Survey Dates: July 2020

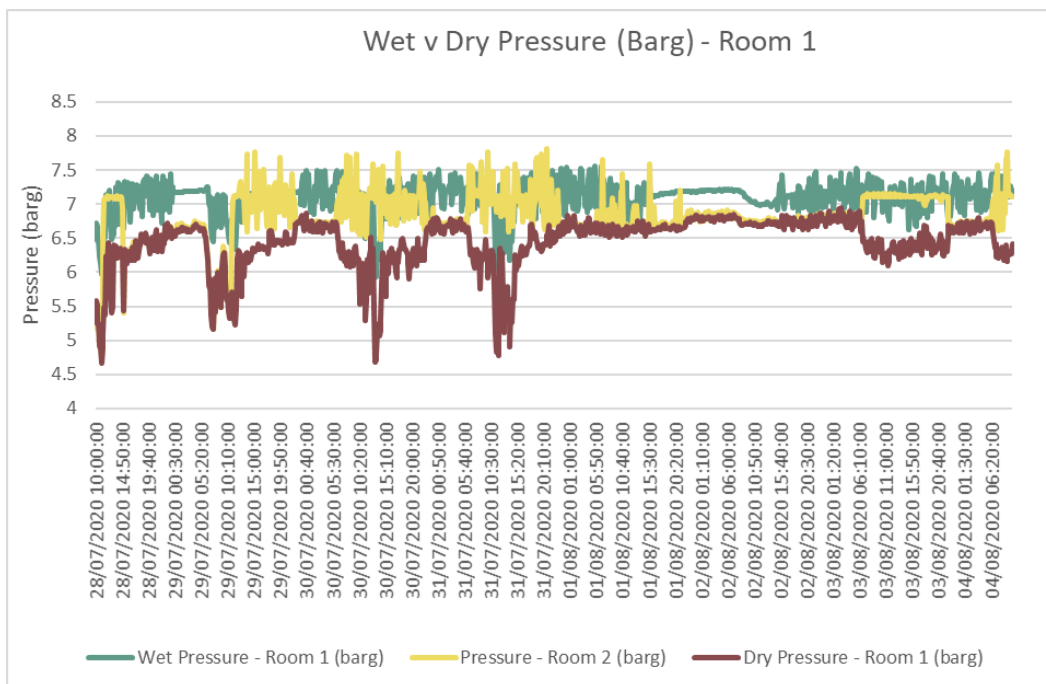
At the time of the survey the site was exceeding the capacity of the main compressor causing the pressure across the system to deteriorate, at times pressure as low as 4.6 bar was recorded. As the site cannot operate at pressures this low, it was forced to switch on the secondary compressor during peak periods to stabilise the system. While this improves the factory pressure it also has a significant impact on the compressed air purity (see dew point and temperature in this section).

Pressure drop across the dryers and filters is within the normal range, however a restricted diameter pipe section between the main receiver, dryer and to the factory is impacting the supply of compressed air. Increasing this pipe size to match the surrounding aluminium will improve supply pressure between 0.3 to 0.5 bar during peak periods.

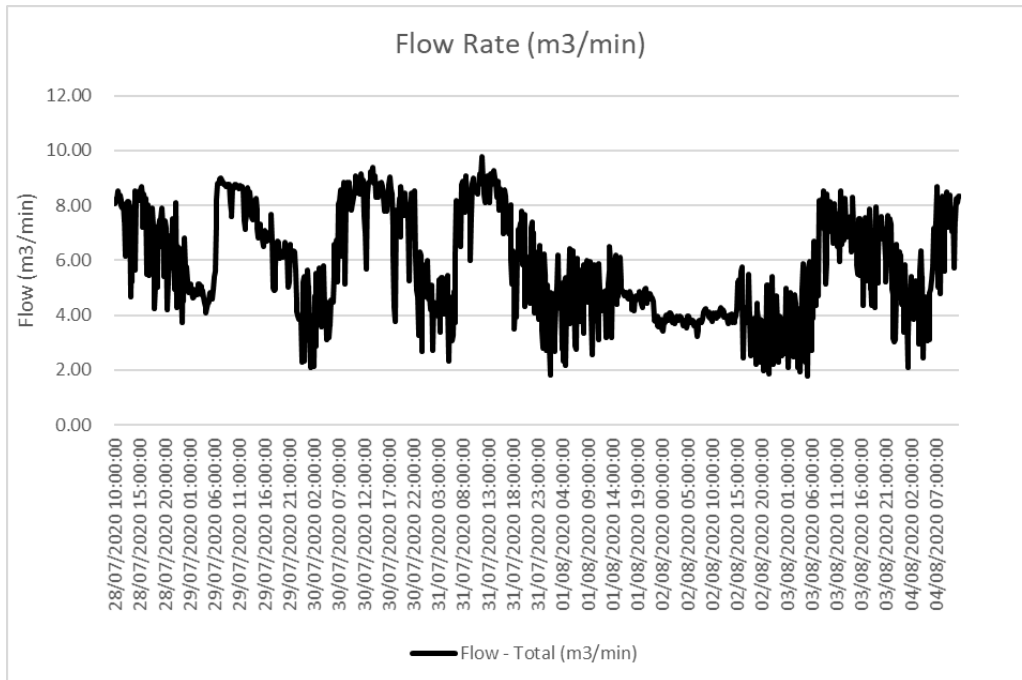
Flow

The flow rate to the factory (after drying), ranges from approximately 2m³/min to 9.8m³/min. This exceeds the main compressor capacity during peak periods when coupled with the purge losses from the desiccant dryer. Thus causing the need for the second compressor.

Repairing leaks and eliminating some inappropriate use will reduce the demand enough for the main compressor to support the entire system, replacing optimising the dryer with alternative technology would further return capacity to the system. However, as the main compressor is nearing end of life consideration should be given to the best way forward.

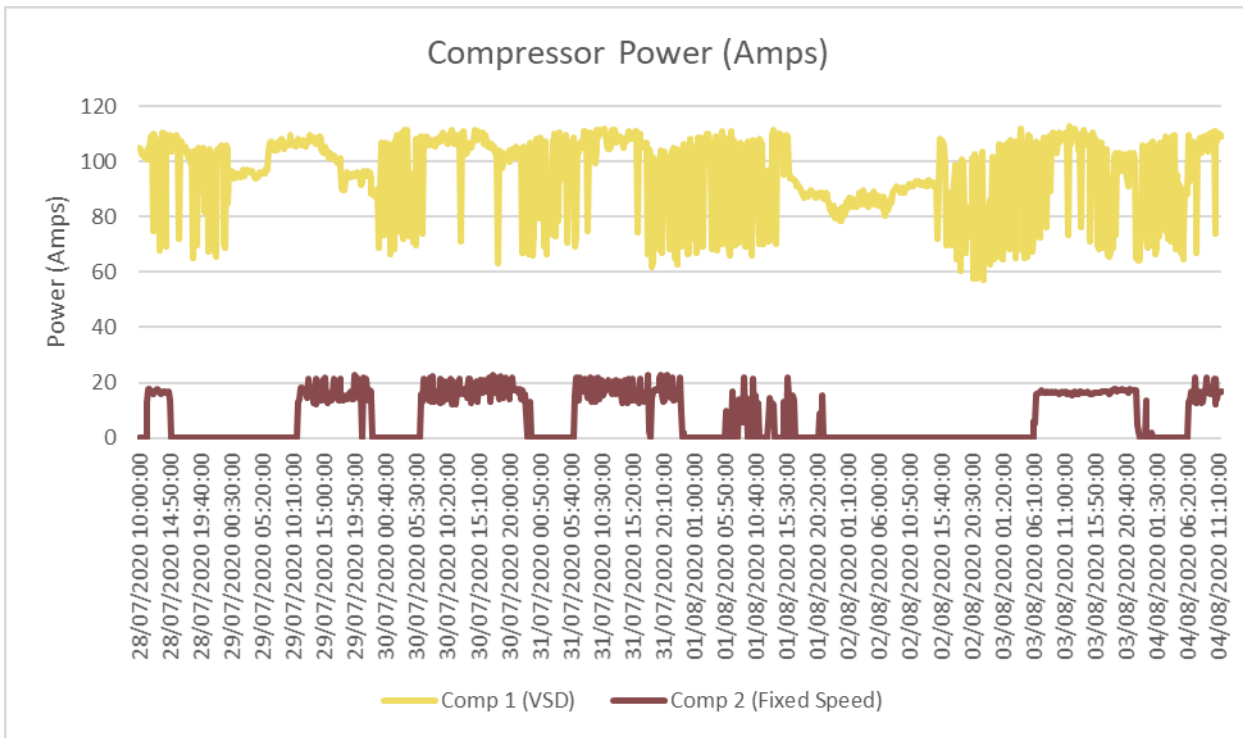
Power Consumption

Both compressors appear to be performing to their specifications, however at times when both compressors are running, they are loading and unloading at the same time, this is being caused by the compressors effectively seeing different system pressures. I.e. Both compressors are controlled by independent pressure sensors on the wet side of the system.

Connecting both compressors to the same receiver will significantly reduce this problem and allow each compressor to be adjusted so that they work more effectively together.

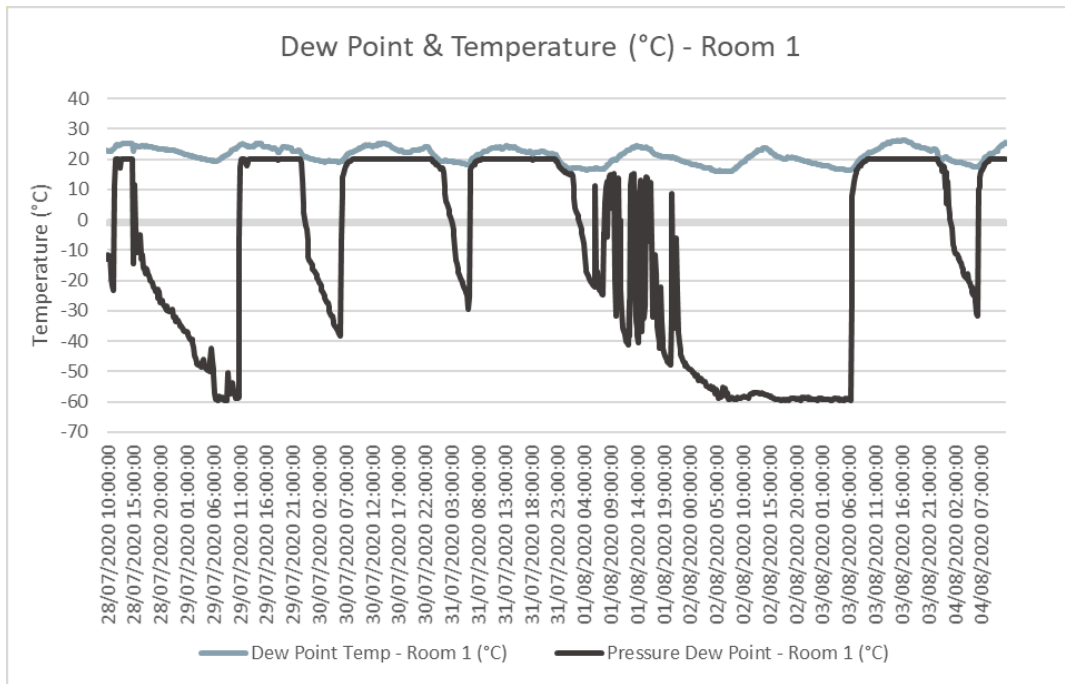
Dew Point & Temperature

The extreme change is caused by the untreated compressed air from the second compressor contaminating the entire system. This is a significant issue that requires immediate attention. Aside from the base issues of condensate in the system, there is notable risk of product contamination. Production should be reduced to a level where the second compressor is not required until it can be moved and connected to the main wet receiver so that this supply can be treated through the existing desiccant dryer and filtration.

Once moved it is expected that the system will take several months before the majority of the contamination is removed from the system, though oil is now likely a permanent feature of the system.

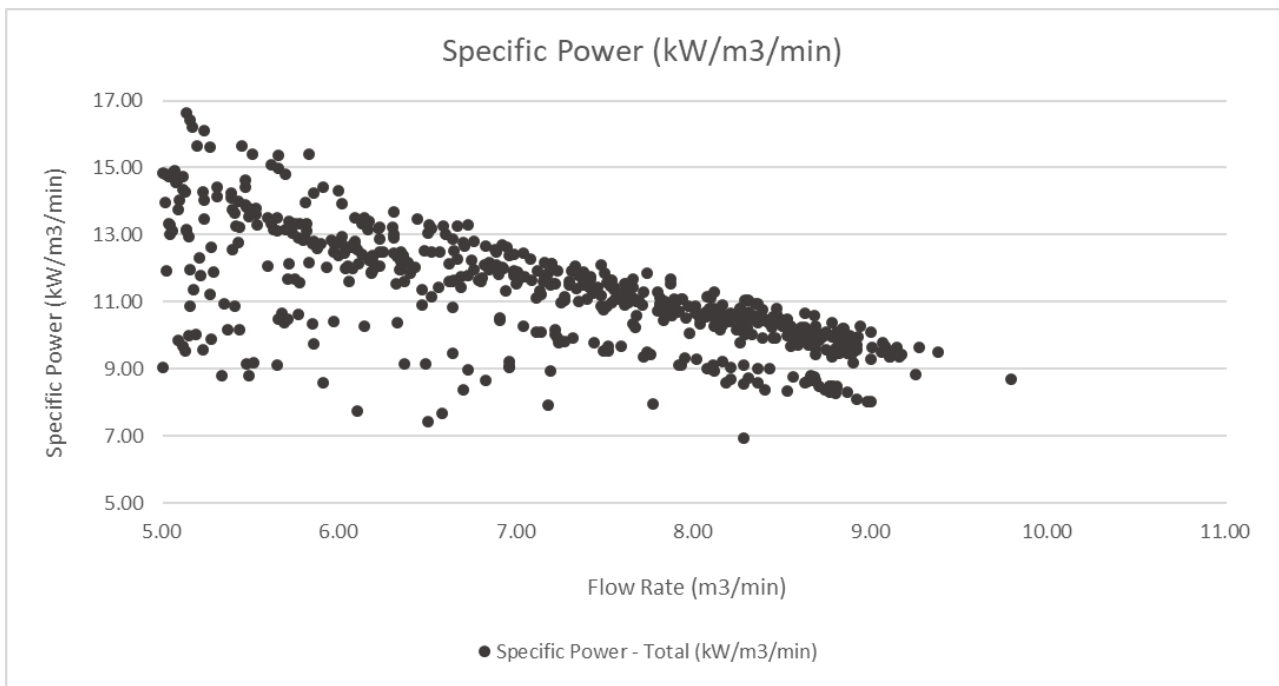
Compressed Air System Efficiency

The system had an average specific power of 13.23 kW/m³/min, which is very high. This is in part caused by the desiccant dryer which purges compressed air to atmosphere as part of its regeneration process. Unless the dryer is changed to an alternative technology little can be done to prevent this.

The net effect would be a reduction in operating costs of between \$33,000 to \$46,000 per year.

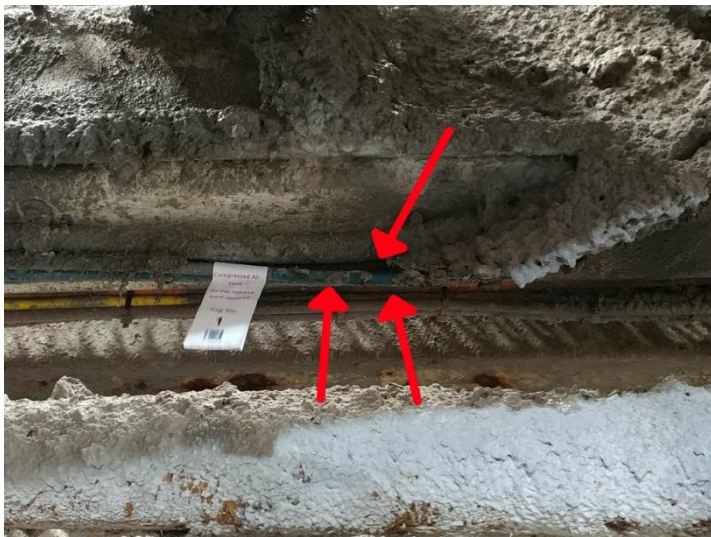
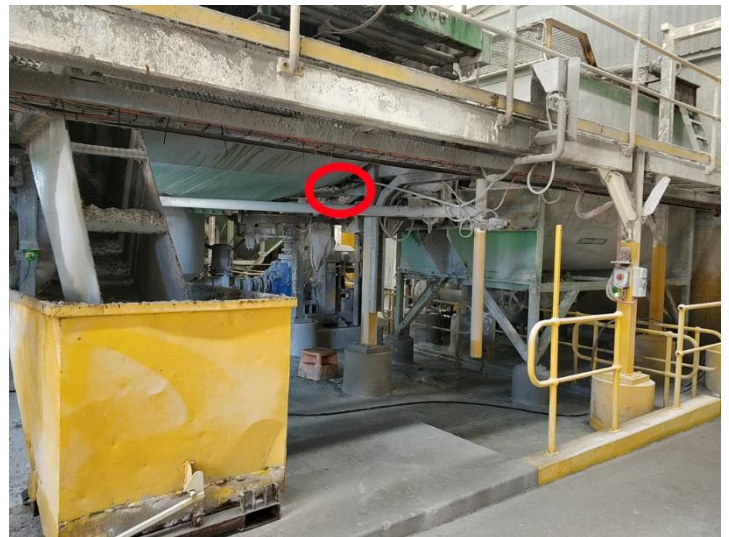
Leak Number:	1	Location:	Dry Foods - Processing
Machine:	Feed Agitator ground

Part Leaking:	Tube	Leak Location:	Hose
Cause of Leak:	Age	Leak Size (1=small, 5=large)	4
Flow Rate	0.186 (m ³ /min)	Annual cost of Leak	\$1,466

Action:	Replace	Estimated Repair Time (min):	20	
Parts Required:	Brand:	Part Number:	Size:	Qty
Push Fit - Joiner	Generic		10 mm	4
Tube	Generic		10 mm	2
Comments:

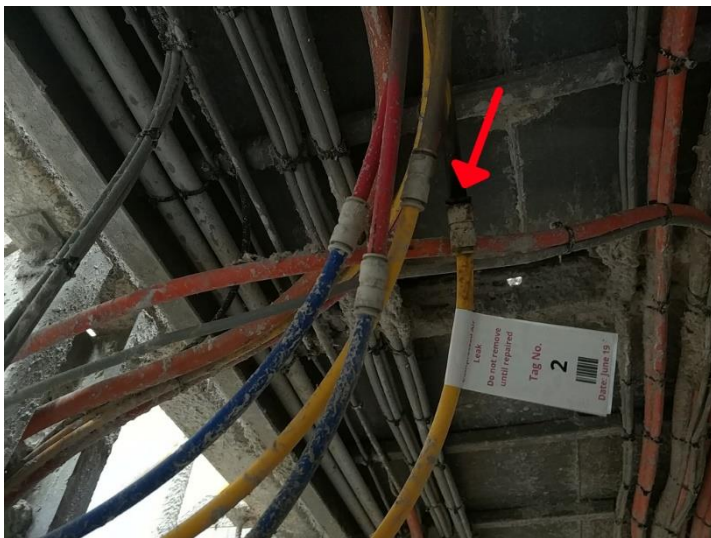
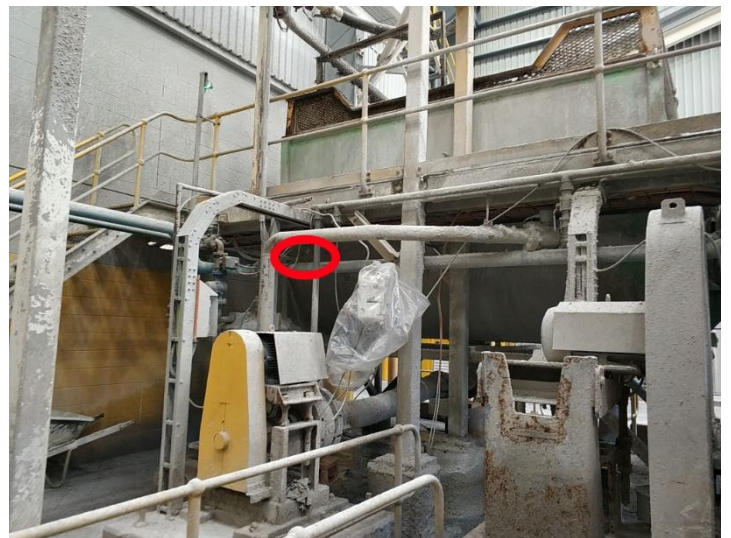
Leak Number:	2	Location:	Dry Foods - Processing
Machine:	Feed Agitator Ground

Part Leaking:	Push Fitting	Leak Location:	Connection
Cause of Leak:	Age	Leak Size (1=small, 5=large)	2
Flow Rate	0.03 (m ³ /min)	Annual Cost of Leak	\$235

Action:	Replace	Estimated Repair Time (min):	10	
Parts Required:	Brand:	Part Number:	Size:	Qty
Push Fit - Joiner	Generic		10 mm	1
Comments:

REPAIRED

Repaired by	CAA	Repaired on (date):	16/4/19
-------------	-----	---------------------	---------

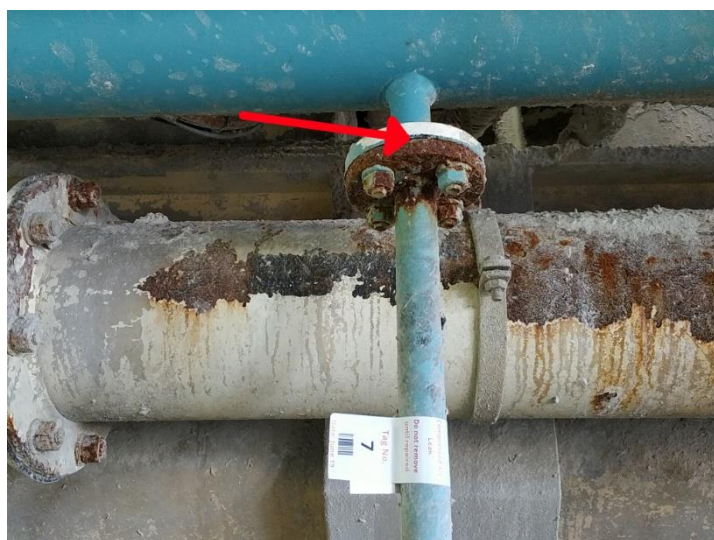
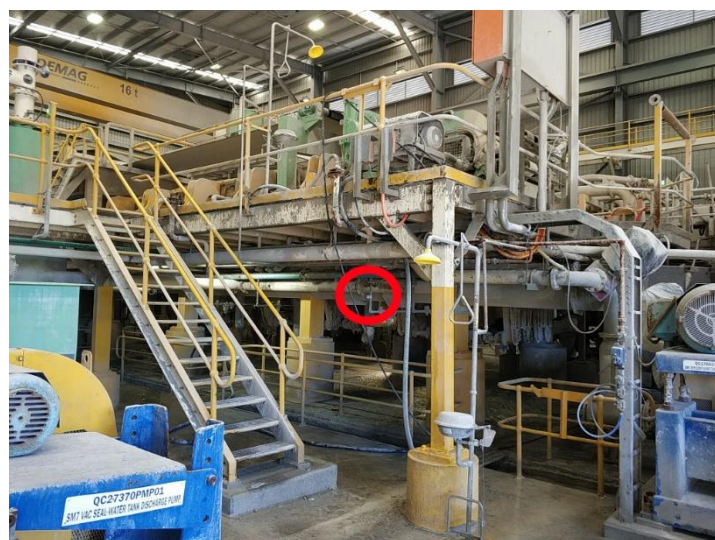
Leak Number:	7	Location:	Roof - Meat
Machine:	Sump piping

Part Leaking:	Flange	Leak Location:	Gasket
Cause of Leak:	Age	Leak Size (1=small, 5=large)	1
Flow Rate	0.002 (m ³ /min)	Annual cost of Leak	\$ 15

Action:	Replace	Estimated Repair Time (min):	30	
Parts Required:	Brand:	Part Number:	Size:	Qty
Gasket	Generic		Other	
Comments:	4 bolt gasket, 1" piping, 120mm diameter flange

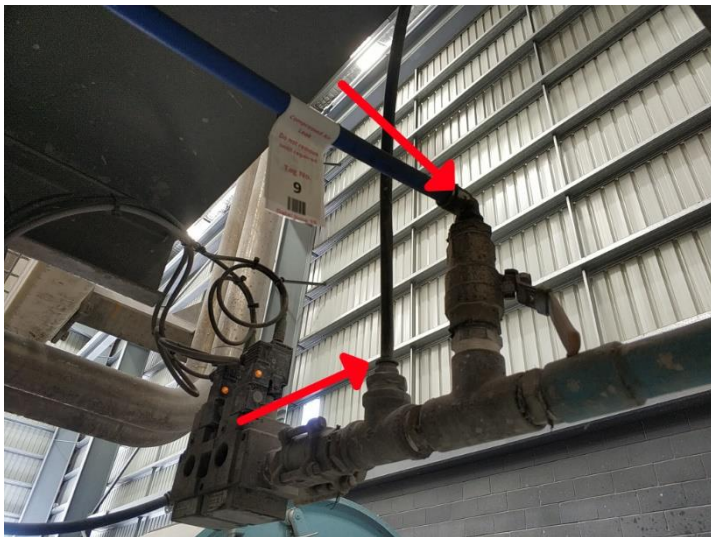
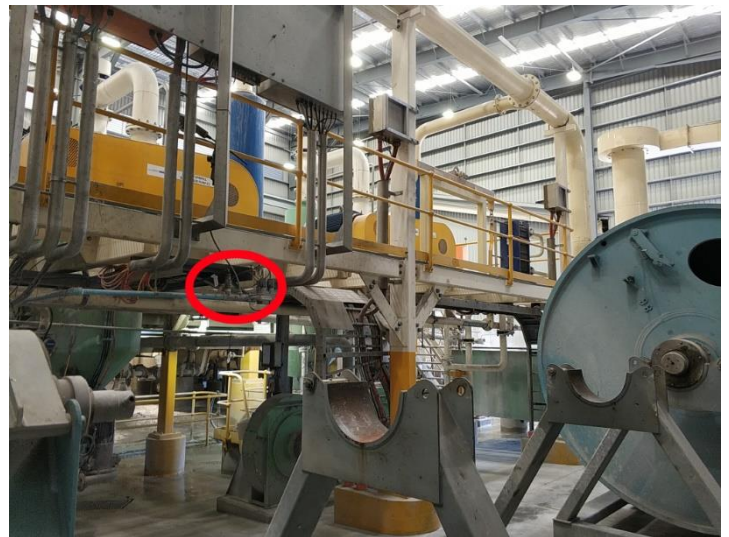
Leak Number:	9	Location:	Packaging
Machine:	Seal Water feed

Part Leaking:	Push Fitting	Leak Location:	Connection
Cause of Leak:	Age	Leak Size (1=small, 5=large)	2
Flow Rate	0.03 (m ³ /min)	Annual cost of Leak	\$235

Action:	Replace	Estimated Repair Time (min):	30	
Parts Required:	Brand:	Part Number:	Size:	Qty
Push Fit - Elbow	Generic		1/2" to 16 mm	1
Push Fit - Straight	Generic		1/2" to 12 mm	1
Comments:
